**Figure 2 Illustration of Work Fragmentation**

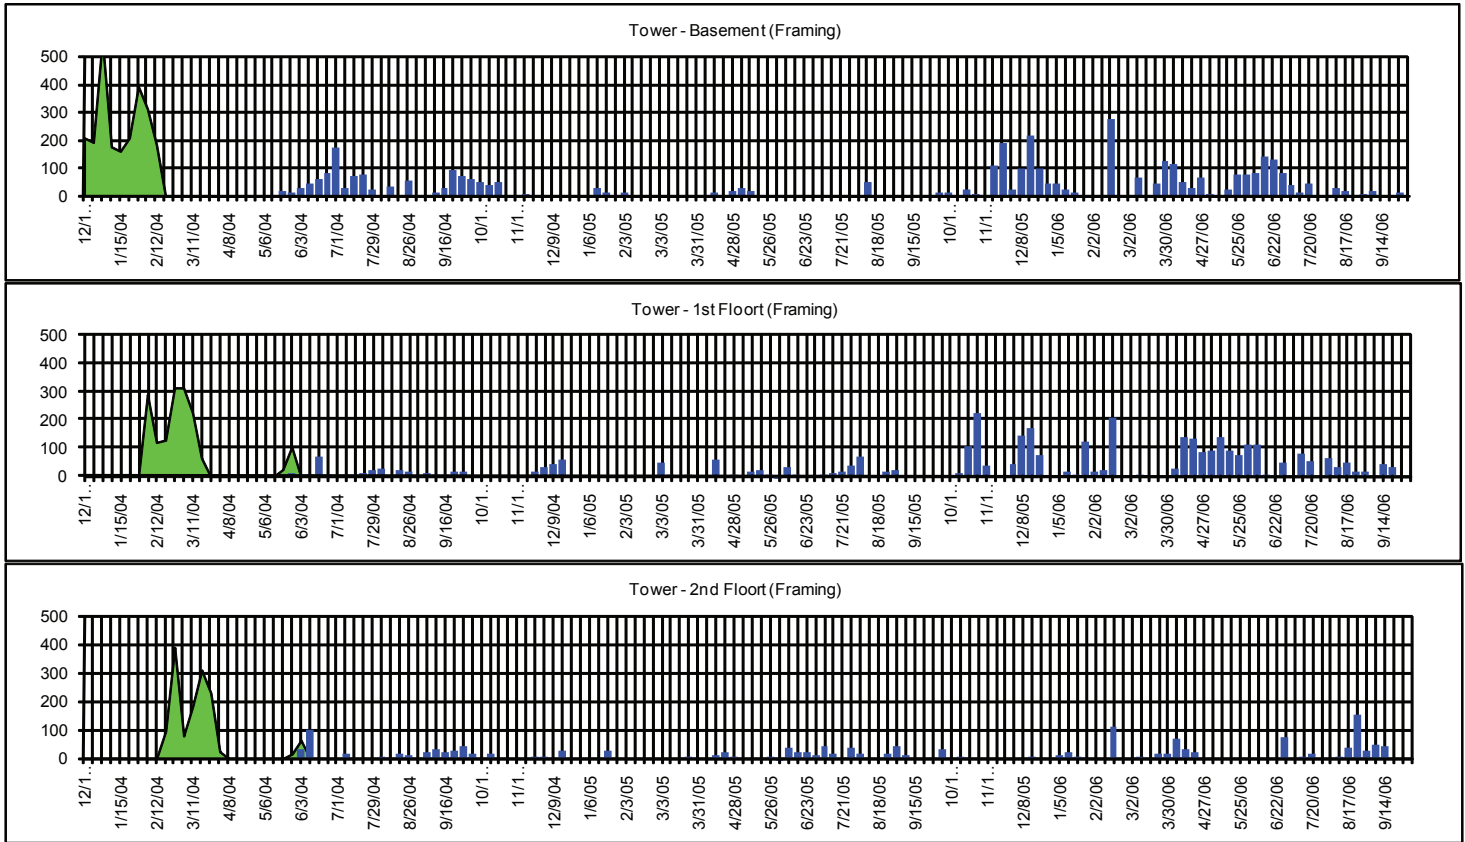
In the figures above, the contractor intended to mobilize to a location two times for corridor and partition walls. As it turned out, he was forced to mobilize and demobilize nearly 20 times at each location. Labor productivity was reduced to more than 30 percent below the estimate.
